Manhole Inspection Summary

Manhole # S67A1_002MH

Location Address: **2200 Edgewater St.**

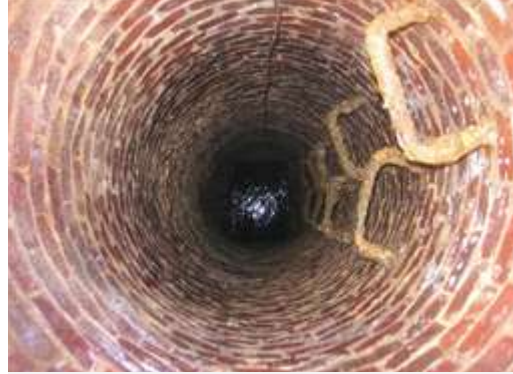
Top View

Comments **CSX RAIL ROAD TRACKS. BESIDE TRACKS ON CSX PROPERTY. BEFORE RAILROAD BRIDGE. LID IS SEIZED ON FRAME. NEEDS NEW FRAME AND LID. THE WHOLE FRAME MOVES OFF FOUNDATION WITH LID TO ENTER.**

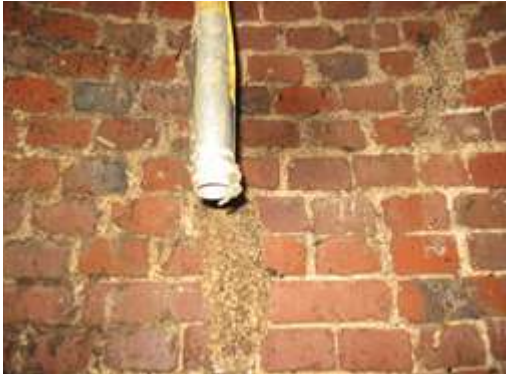
Defect 4

Surcharge ☒ Evidence Of Surcharge Depth: **10** (ft.) ☐ Active Surcharge Present

Surcharge on wall

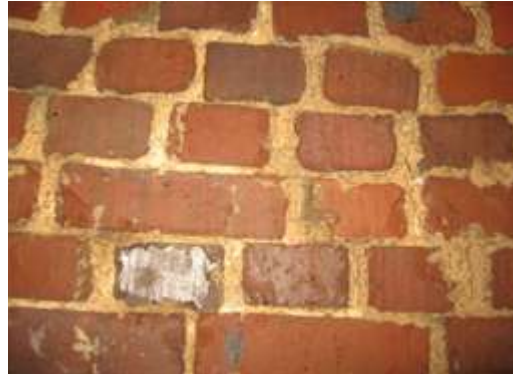
Defect 2

Infiltration: ☐ None ☒ Joint ☐ Cracks ☒ Mortar ☐ Roots ☐ Wall

cracked mortar and joints

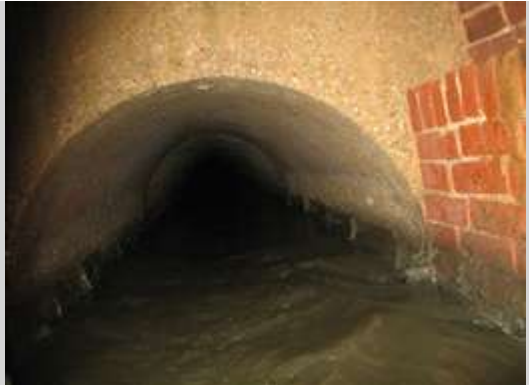
12 O'Clock Outflow

36 in. Circular Gravity Sewer
Pipe Out @ 12 O'Clock

Pipe Height: **36** (in.) Rod and Bar (Angled)
Pipe Material: **Concrete** ☐ Pipe Lined
Invert Depth: **31.13** (ft.) Flow Characteristics: **None**
Deposits: ☒ None ☐ Mud ☐ Sludge ☐ Debris ☐ Grease
Silt Depth: (in.) Deposits Extent:
Infiltration: **None** Pipe Seal Cond: **Sound**

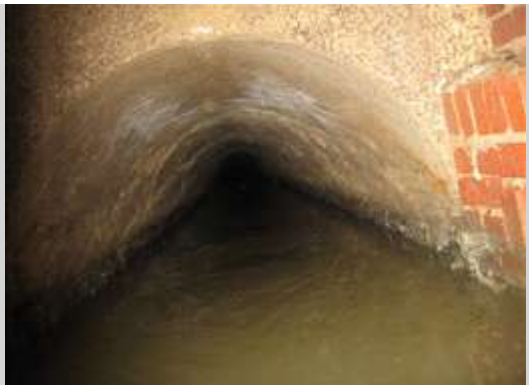
6 O'Clock Inflow

36 in. Circular Gravity Sewer
Pipe In @ 6 O'Clock

Pipe Height: **36** (in.) Rod and Bar (Angled)
Pipe Material: **Concrete** ☐ Pipe Lined
Invert Depth: **31.00** (ft.) Flow Characteristics: **Fast**
Deposits: ☒ None ☐ Mud ☐ Sludge ☐ Debris ☐ Grease
Silt Depth: (in.) Deposits Extent:
Infiltration: **None** Pipe Seal Cond: **Sound**

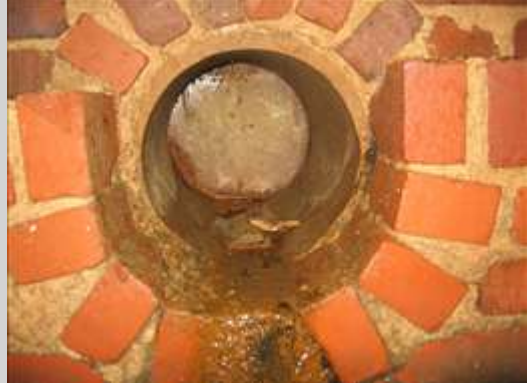
9 O'Clock Inflow

12 in. Circular Gravity Sewer
Pipe In @ 9 O'Clock

Connects To: **Stub connection / abandoned**
